# Deviation and CAPA Report

Meridian Biologics — Nashport Manufacturing Facility

| Deviation ID: | DEV-2026-0143 | Classification: | Major |
| Product: | NimBlend rHu-Insulin Analog, 10 mL MDV | Batch/Lot: | MB-INS-2451-07 |

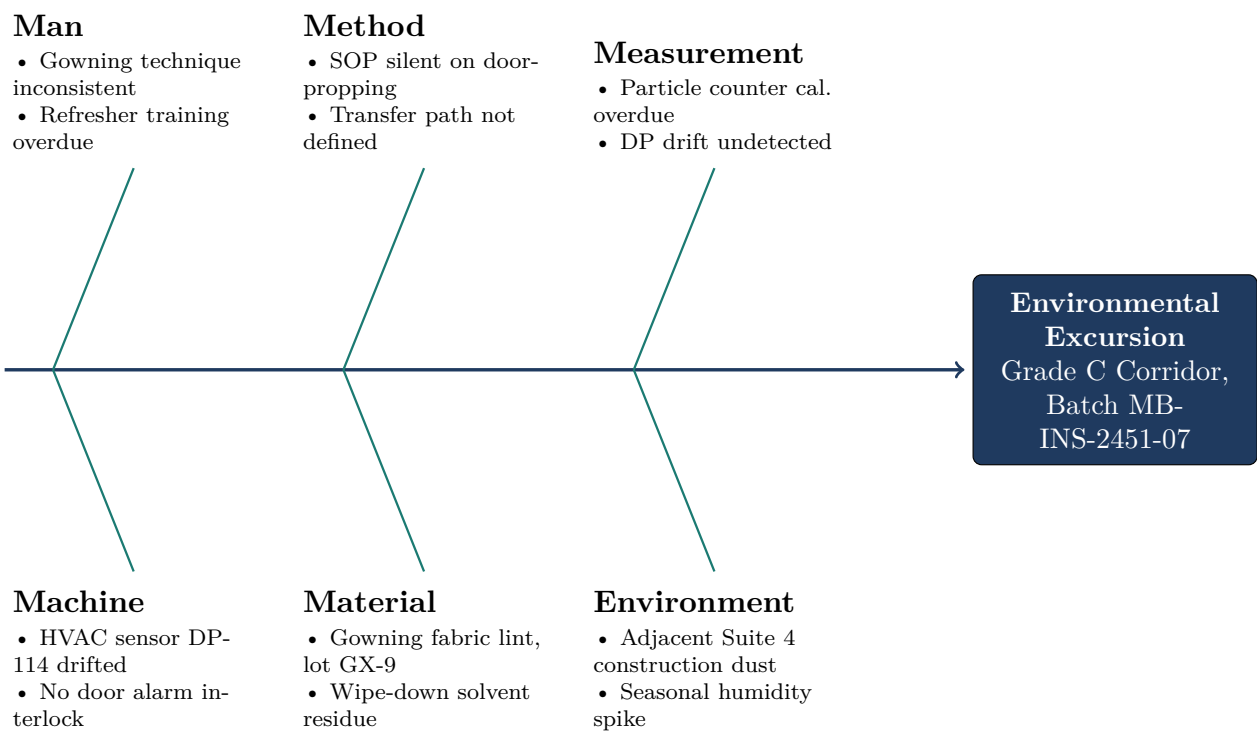
2.1 Ishikawa (6M) Diagram

Figure 1: Ishikawa (6M) diagram enumerating candidate causes for the Grade C corridor environmental excursion during Batch MB-INS-2451-07.

Physical evidence (the out-of-cascade DP reading, the door-propping observation, and the sensor’s calibration record) converged on the Machine/Measurement branches. The team drilled down as follows:

**Root cause:** The Grade C corridor differential-pressure sensor (DP-114) drifted undetected because the site's metrology scheduling system does not flag overdue calibrations for corridor-level utility instrumentation. This allowed a gradual loss of airflow cascade to go unnoticed until a transient door-opening event during material transfer permitted sufficient lower-grade air ingress to produce a viable particle excursion.

| ID | Action Description | Type | Owner | Due Date | Status |
|---|---|---|---|---|---|
| CAPA-1 | Recalibrate and functionally verify HVAC differential-pressure sensor DP-114; replace transmitter if drift recurs on verification. | Corrective | Tom Reyes<br>Facilities Eng. | 28 Jun 2026 | Closed |
| CAPA-2 | Install a door-held-open alarm interlock on all Grade C anteroom doors, with local audible alert and BMS event log. | Preventive | Tom Reyes<br>Facilities Eng. | 15 Jul 2026 | In Progress |
| CAPA-3 | Retrain all Grade C-qualified personnel on gowning technique and material transfer practice per SOP-MFG-221, with practical assessment. | Corrective | Priya Naka-<br>mura<br>QA Training | 30 Jun 2026 | Closed |
| CAPA-4 | Reduce the calibration interval for corridor-level DP and particle-counting instrumentation from 12 to 6 months in the metrology master schedule. | Preventive | Grace Lin<br>Metrology | 10 Jul 2026 | In Progress |
| CAPA-5 | Revise SOP-MFG-221 to explicitly prohibit propping open Grade C anteroom doors and add floor-marked transfer routing to avoid the practice. | Preventive | Rahul Advani<br>QA Doc. Con-<br>trol | 01 Aug 2026 | Open |
